SAUGUS RIVER BASIN  
SAUGUS, MASSACHUSETTS

GRISWOLD POND DAM  
MA 00292

**PHASE I INSPECTION REPORT  
NATIONAL DAM INSPECTION PROGRAM**

OCTOBER 1979

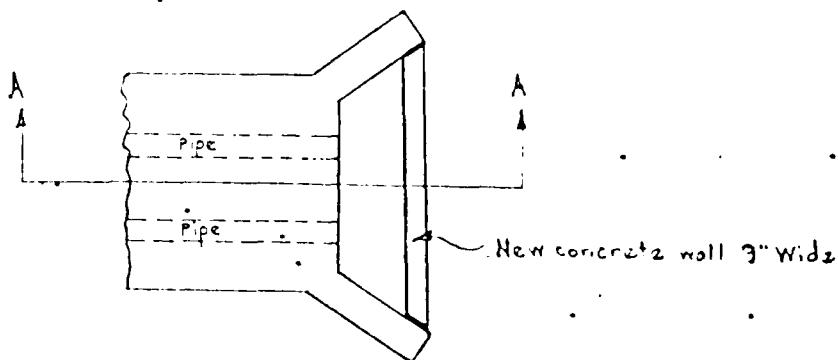
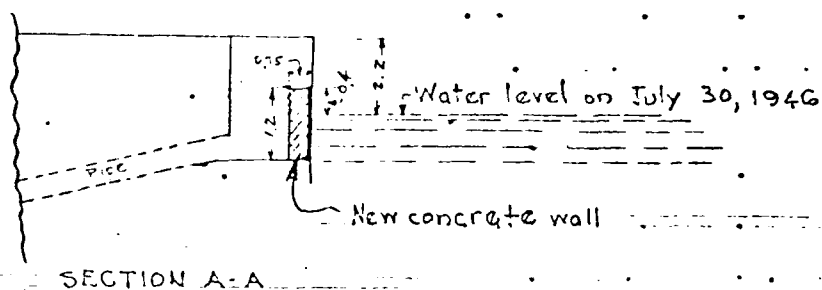
SKETCH SHOWING NEW WALL. Wall built sometime between June 1944 and July 1946  
July 30, 1946

1946 July 30, S.W.Woodbury, Insp. Went to dam alone. Further inspection is needed to see that new 9" concrete wall is removed. A concrete wall 9" wide and 1'-3" high has been built across the upper end of the culvert between the wing walls which decreases the freeboard 1'-3" (see sketch). Conditions below the dam are the same. Water level today is 6.5' above the invert of the pipes. Condition of the dam is the same.
